## GEOTECHNICAL INVESTIGATION OF KARIBA DAM PLUNGE POOL

### SUMMARY

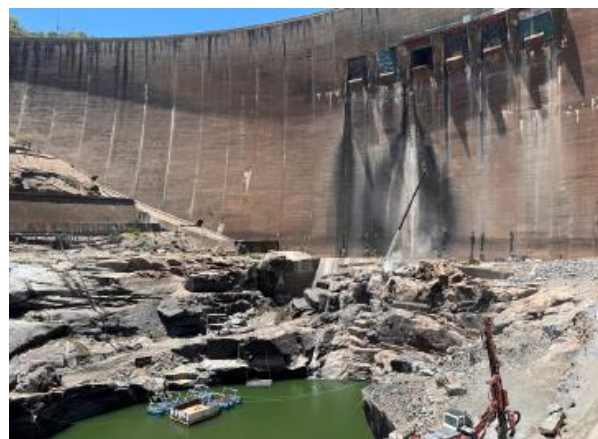
A watertight coffer dam was constructed to enable the drilling of a series of short, cored holes into the biotite gneiss bed rock. Core retrieved from these holes could be analyzed in a laboratory while in-situ measurements could be conducted in the now open hole.
